Fighting a beating

Congested hot-mix asphalt intersection in Maryland shows little signs of wear-and-tear

by **Dan Brown**

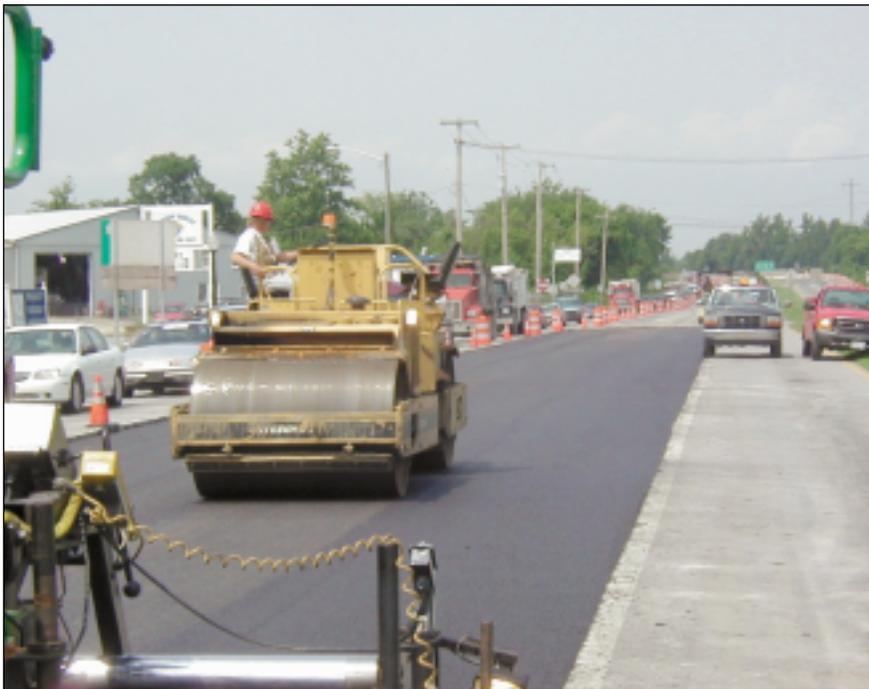
Faced with a rutting problem, the Maryland State Highway Administration decided to compare the performances of hot-mix asphalt and portland cement concrete by giving each industry one intersection to rebuild along U.S. Route 40.

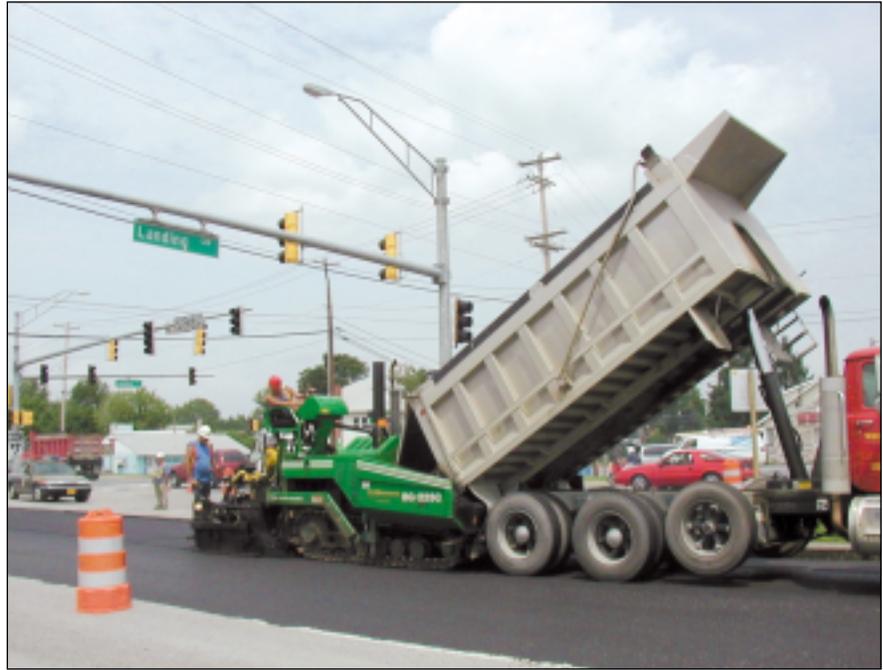
The hot-mix asphalt industry chose two Superpave mixes to use in rebuilding its intersection, the corner of Route 40 and Maryland Route 213 near Elkton, Md.

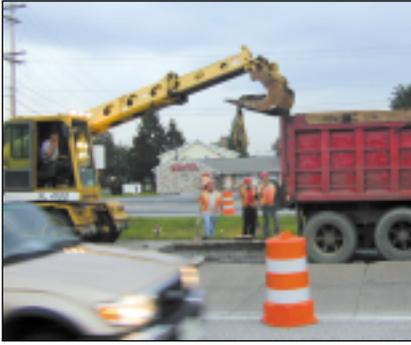
Gradall excavators with stripping buckets were used for concrete removal.

"We used two Gradall XL-4100

excavators with stripping buckets,” said Kiebler. “We picked up the concrete slabs and stacked them into eight tandem-axle dump trucks.”

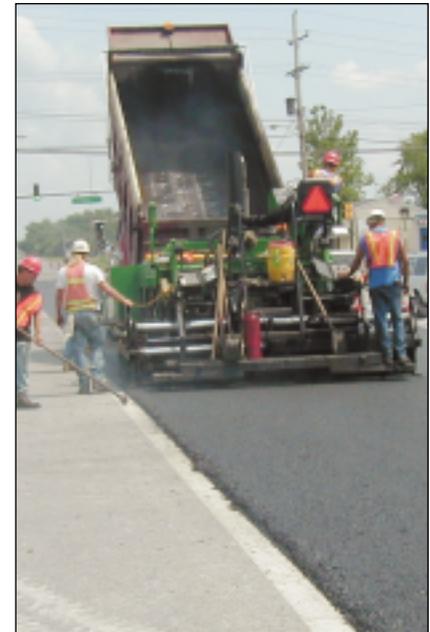
Tests confirmed the HMA mix was quite rut resistant.

Extensive materials testing was conducted prior to construction. The Superpave mix designs developed at the Asphalt Institute in Kentucky were replicated at the Koch Materials laboratory in Pennsauken, N.J. Samples of the proposed mixes were sent to Koch's laboratory in Terre Haute, Ind., where Hamburg Wheel Tracking Tests confirmed that the proposed mixtures were quite rut resistant.

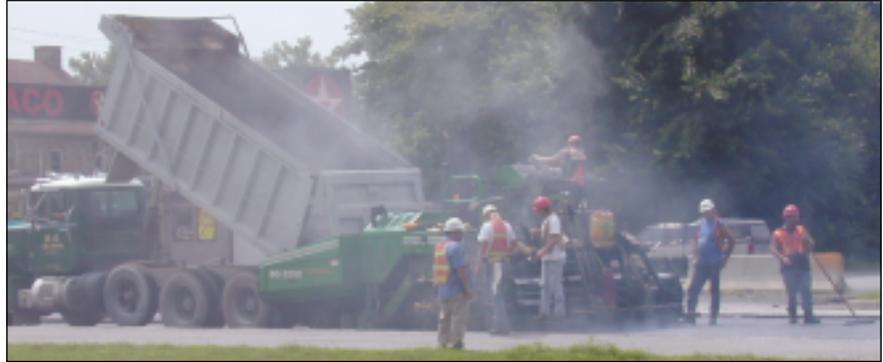
The paving operation consisted of one Barber Greene 225 paver.

Simons’ paving operation consisted of one Barber Greene 225 paver fed by six tandem-axle end-dumps hauling HMA.

“We paved 12 ft wide and laid down two lifts at a 4-in. depth to make the 8 in.,” said Kiebler.

The mix design: a Superpave with 25 mm top size aggregate and a PG 70-22 grade of asphalt cement. Compaction was handled with two Ingersoll-Rand rollers, a DD-90 and a DD-110. Paving took just eight hours, and by 5:00 p.m. on Aug. 2 the pavement was opened to traffic.

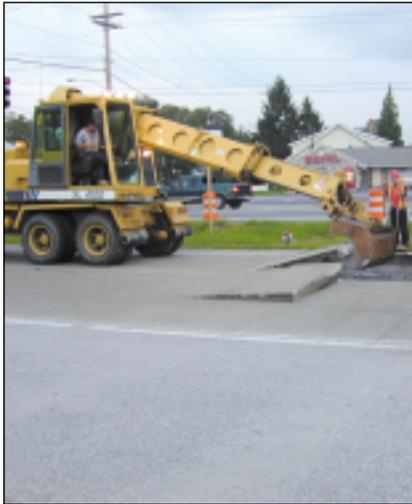
Concrete removal took just six hours.

Concrete removal took just six hours.
